ENGINEERING REPORT

FAA CONTRACT NO. DTFA03-02-C-00044 PHASE 1, CLIN 0001e (TASK 5) - REMOVAL OF SPECIMENS REPORT

This report documents the physical disassembly of retired aircraft N474DA to remove specimens for destructive evaluation. The objective of the disassembly was to remove the target structures required for evaluation without subjecting them to puncture, overload, or any other damage that would render them unusable for the intended research.

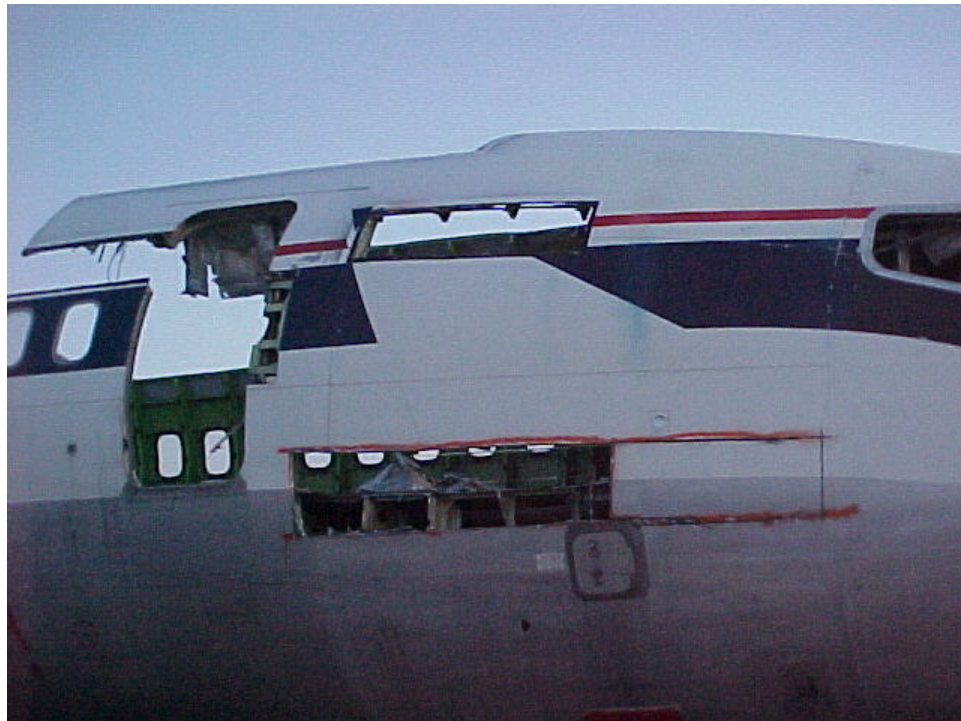
Figure 73: Section 41 after F14 was removed

Figure 73: Section 41 after F14 was removed
